Buncefield Fire

Quick Look Report

bürkel baumann schuler

Swiss Fire Brigade Association

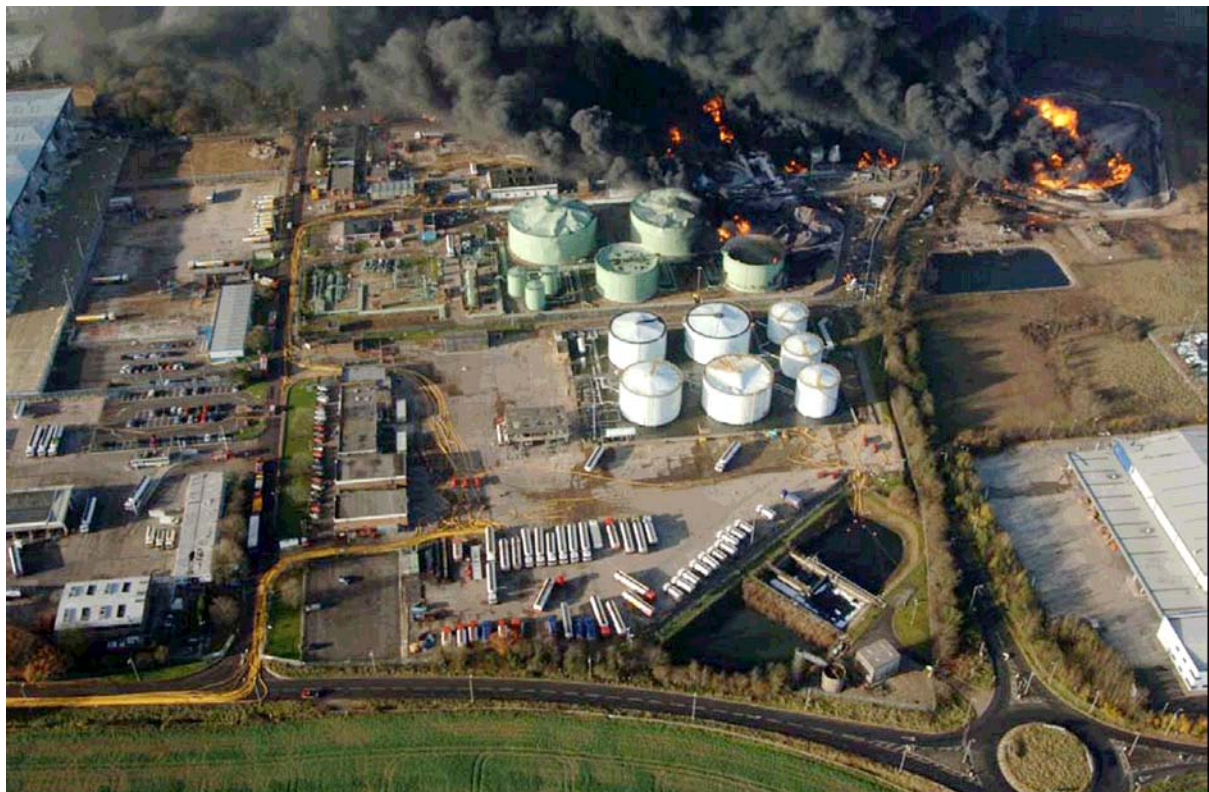
Aerial photograph from the east, with the hosepipes at the entrance to the storage tank depot in the foreground. The seven intact white tanks (“HOSL East”) and the pale green *British Pipeline Agency* tanks behind them and partly affected by the fire are easily recognisable. Of the two Tanks 7 and 8 with floating roofs, Tank 8 (right) has burnt out. The content and thus the danger emanating from Tank 7 were for a long time unknown.

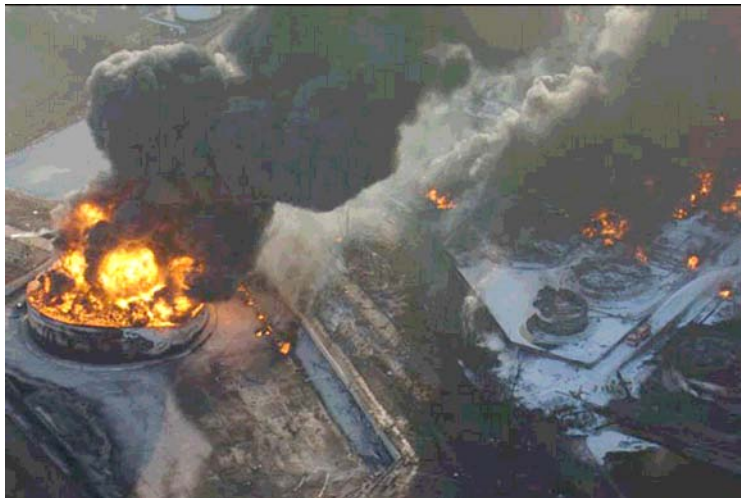
The situation on Monday, 12th December. The large Tank 12 (left) is fully alight but is not being extinguished. The burnt-out Tanks 913, 914, 915 (at far right at the edge of the photo) and 916 can be recognised. Smaller fires are also visible at numerous points in the foam blanket alongside the tanks.

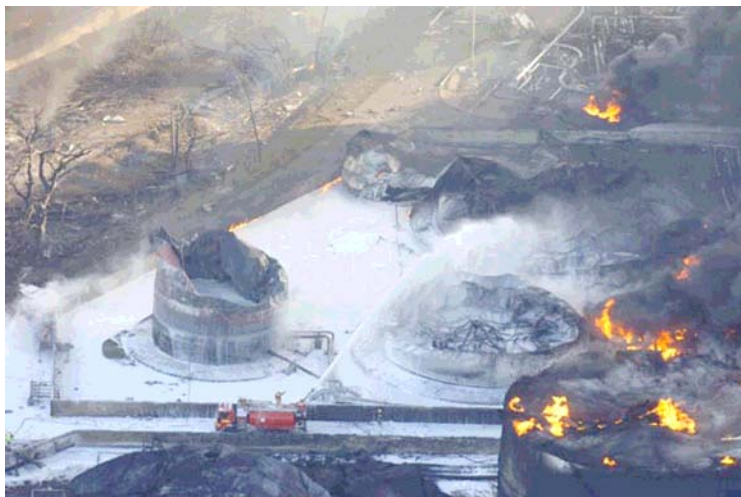
Fire-extinguishing vehicle with foam monitor on the road between Tanks 915 and 912 (in the foreground) and 916 and 913 (from left to right). The tanks are burnt out except for a small seat of fire on the roof of Tank 912. The foam carpet on the ground largely prevents the outbreak of fires. However, the small seats of fire along the bund wall are interesting.

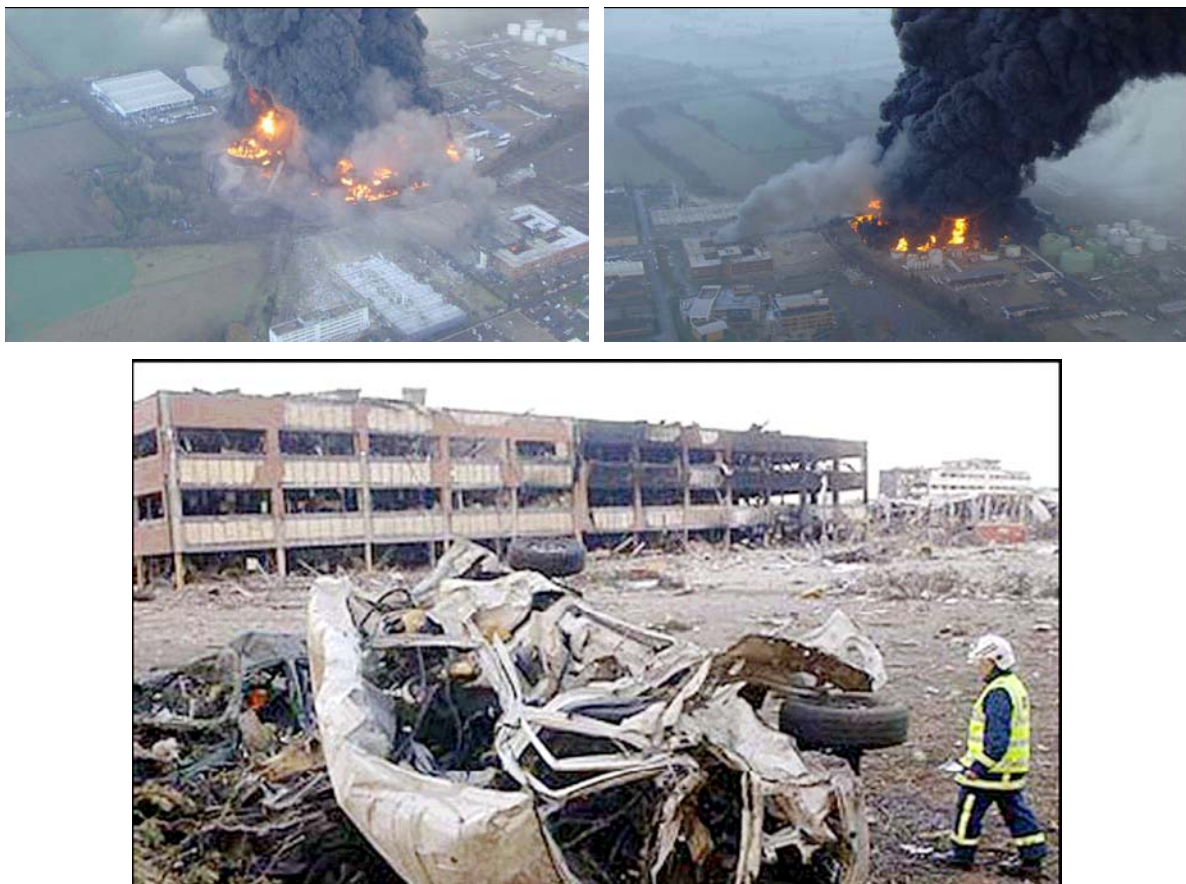
As a consequence of the thermal effects of the explosion and subsequent fires, a part of the *Northgate Information Solutions* office building at a distance of about 150 m also caught fire. The building fire is recognisable by the white smoke plume in the right-hand photograph below. Flames are also visible in the inner courtyard of the building in the left photo below.

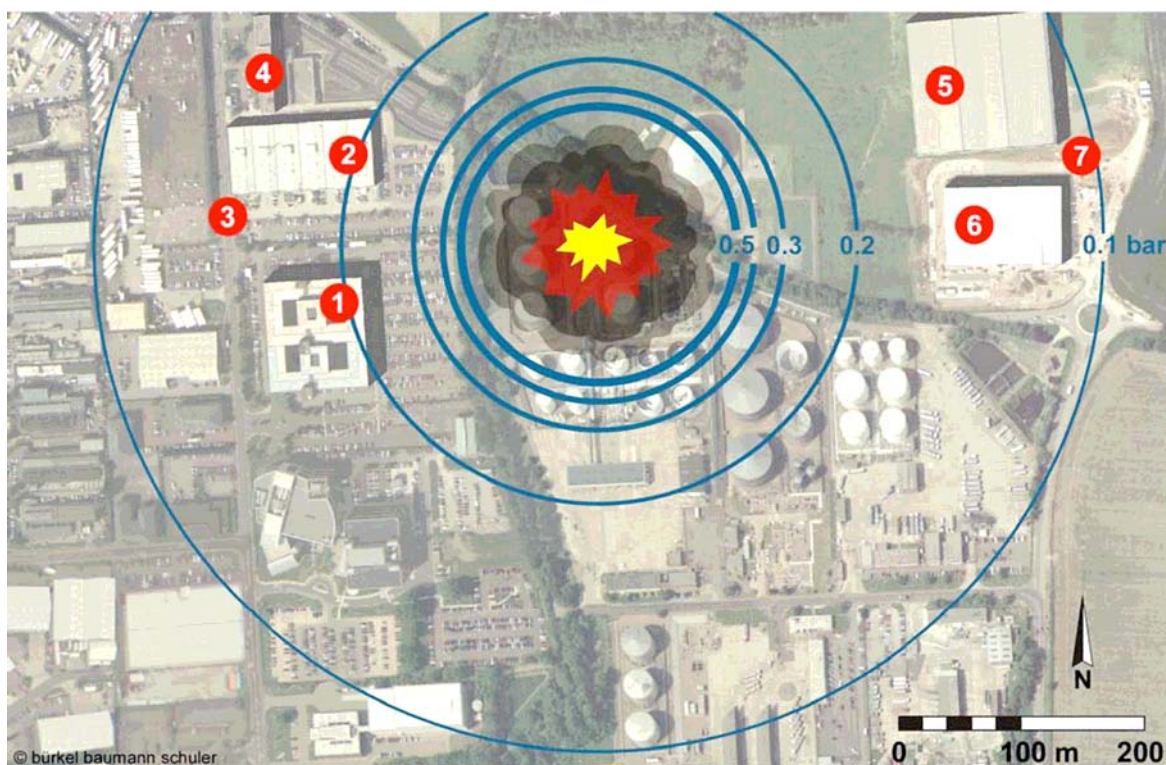
Conclusions can be drawn about the propagation of the overpressure wave based on the damage to the surrounding above-ground buildings/structures and the reported effects of the pressure at a greater distance, together with the eardrum injury to the tanker vehicle driver about 200 m away. This is illustrated in the diagram below. An atmospheric blast wave of this intensity is the result of an explosion with a TNT equivalent of about 15,000 kg.

It is apparent from the illustration that the peak overpressure of the incident atmospheric blast wave was probably slightly more than 0.2 bar at the *Northgate* building (1) and at the *West Hall* (2). The overpressure was probably about 0.15 bar at the *Fujifilm* building (4) and the two storage halls to the east (5) and (6). The magnitude of the peak overpressure was still about 0.05 bar at a distance of 800 m.

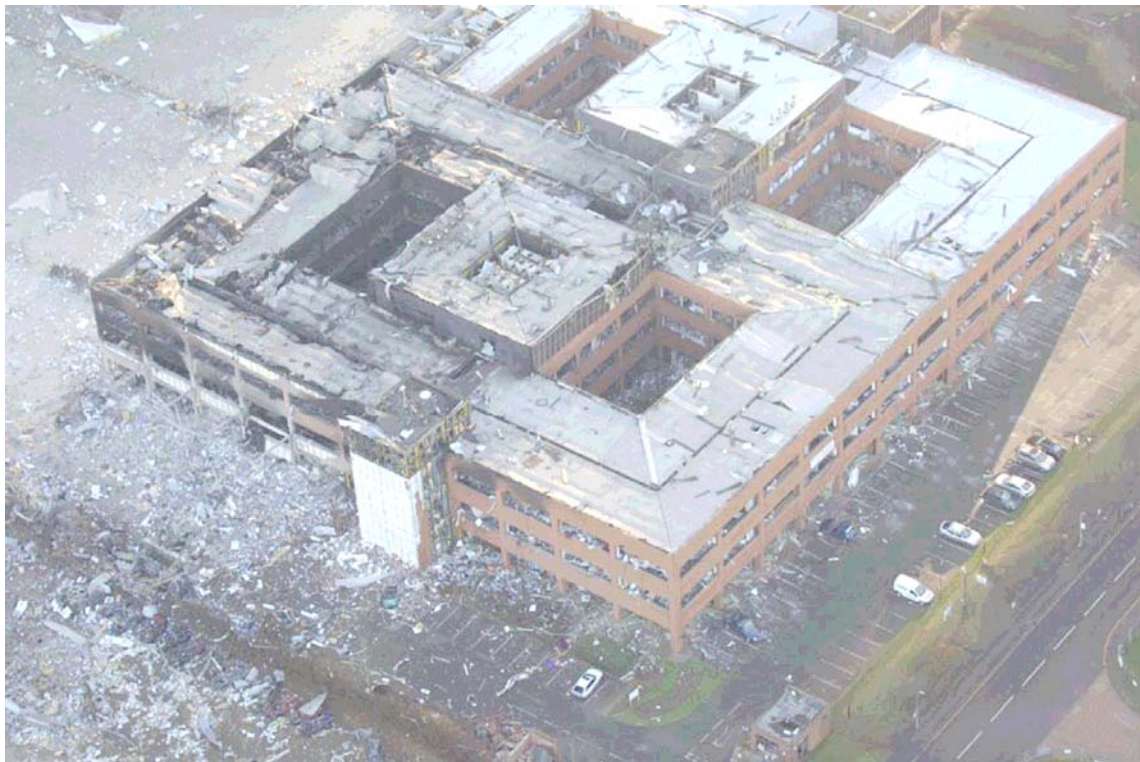
Aerial photograph of the head office of the *Northgate Information Solutions* Company

(1) Northgate

The peak overpressure of the reflected atmospheric blast wave was probably approx. 0.5 bar. The building is generally severely damaged. The window glazings have been shattered on the entire building (including on the rear side of the building). Façade claddings have been torn away. However, the load-bearing security (probably a steel-reinforced concrete supporting structure) is likely to be still guaranteed. It is difficult to judge which damage has resulted from the atmospheric blast wave and which from the following building fire.

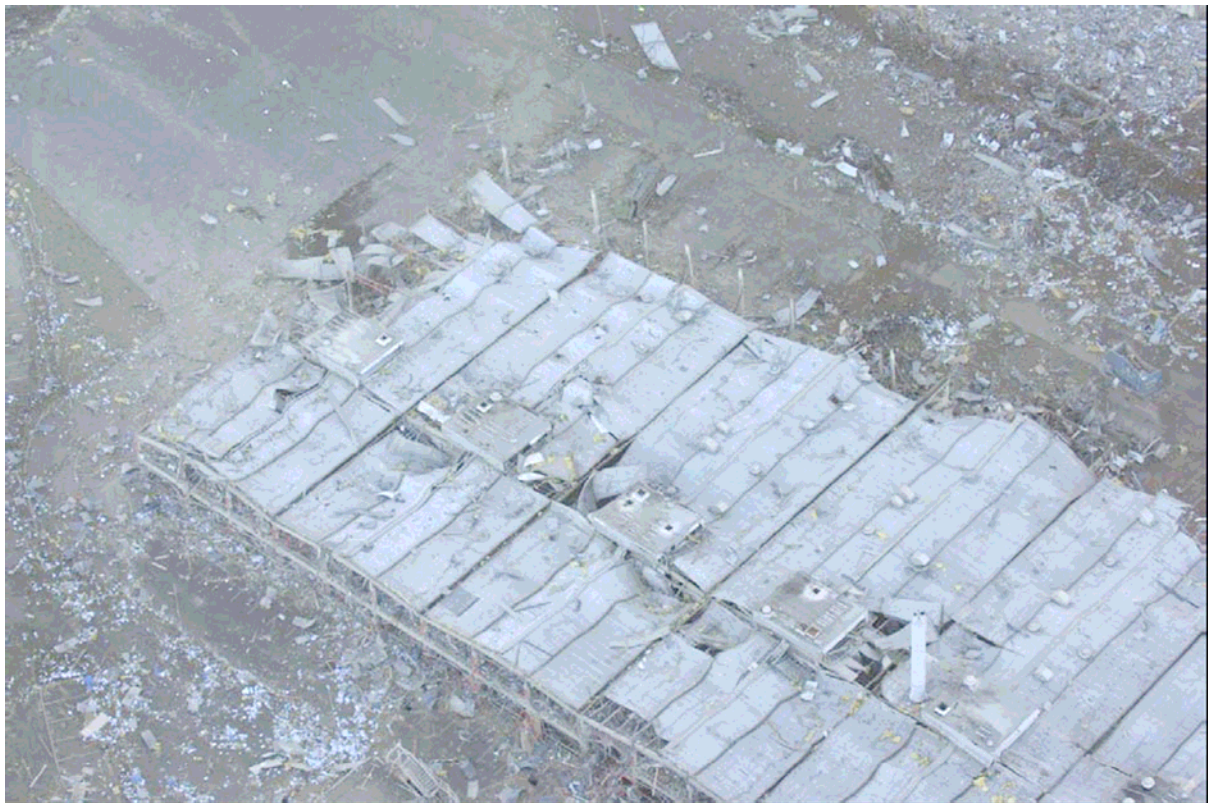
Aerial photograph of the “West Hall”

(2) West Hall

For the south-eastern corner of the “West Hall” building, the peak overpressure of the reflected atmospheric blast wave is estimated to be 0.5 bar. The hall was completely destroyed by the blast wave. Large sections of the supporting structure of the hall have been destroyed and the roof of the most severely affected part of the building has caved in. Because of the generally light-weight construction method, the sheet metal claddings of the outer walls and the roof have been torn away by the atmospheric blast wave.

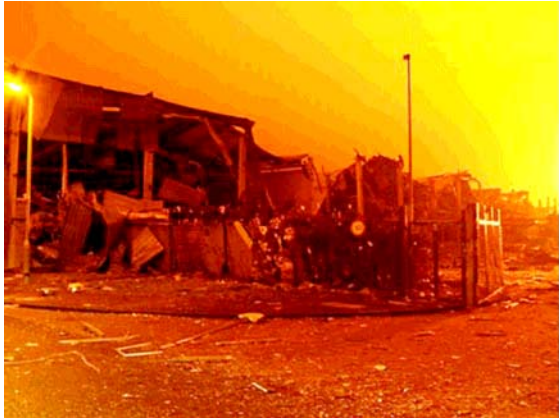
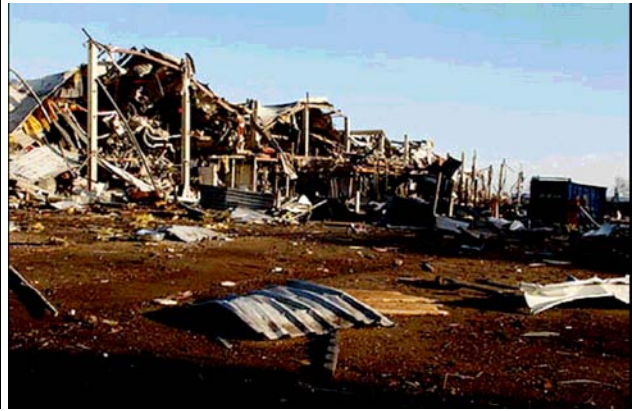
(3) West Entrance

The maximum overpressure of the reflected atmospheric blast wave at the entrance to the industrial estate on the west side probably still amounted to about 0.3 bar. The completely destroyed “West Hall” is recognisable in the photos below.

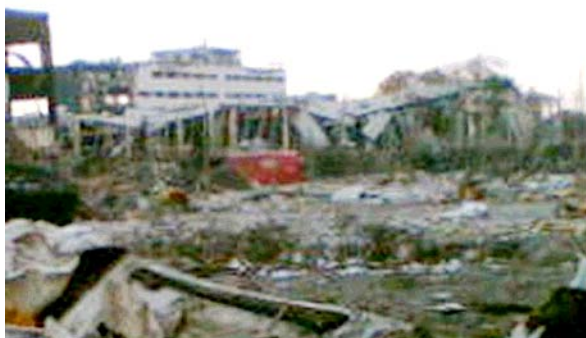
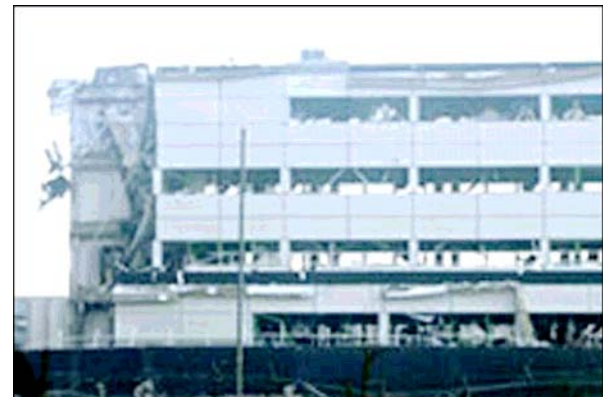
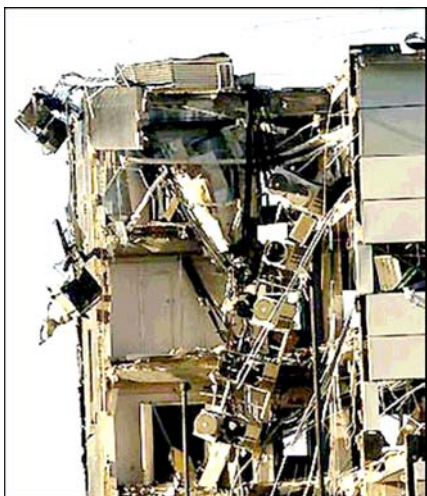
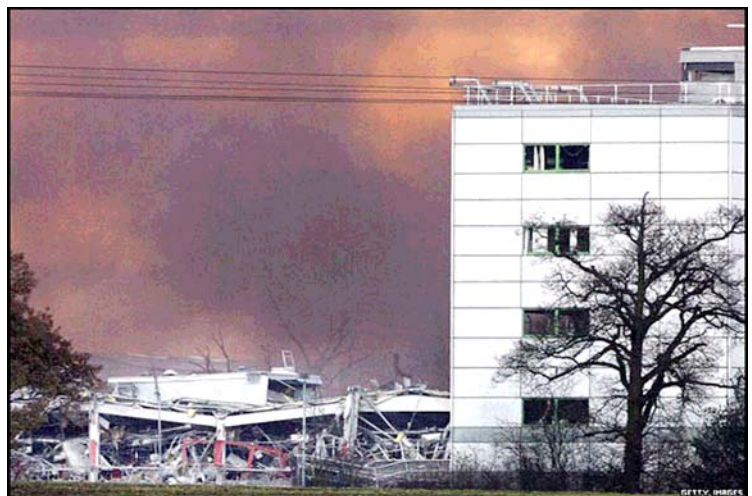
(4) Fujifilm

A reflected overpressure of 0.3 to maximum 0.4 bar probably acted on the east façade of the *Fujifilm* building. The building was seriously damaged at the corner of the building situated nearest to the explosion, façade claddings and roof superstructures being torn away. The glass windows were destroyed throughout the entire building.

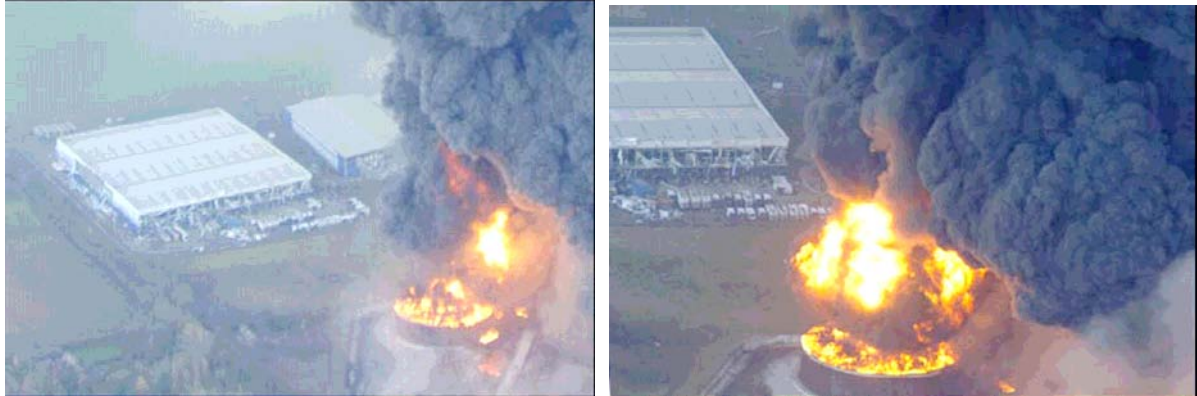
The two industrial and storage halls lie to the east at a distance of approx. 250 m from the presumed site of the explosion. The atmospheric shockwave reflected vertically at the west façades of the halls had an estimated peak overpressure of 0.3 – 0.4 bar. This shockwave destroyed the claddings of the hall buildings along the entire length of the façades.

Hall (5) at the left and Hall (6) at the right, with the burning Tank 12 in the foreground

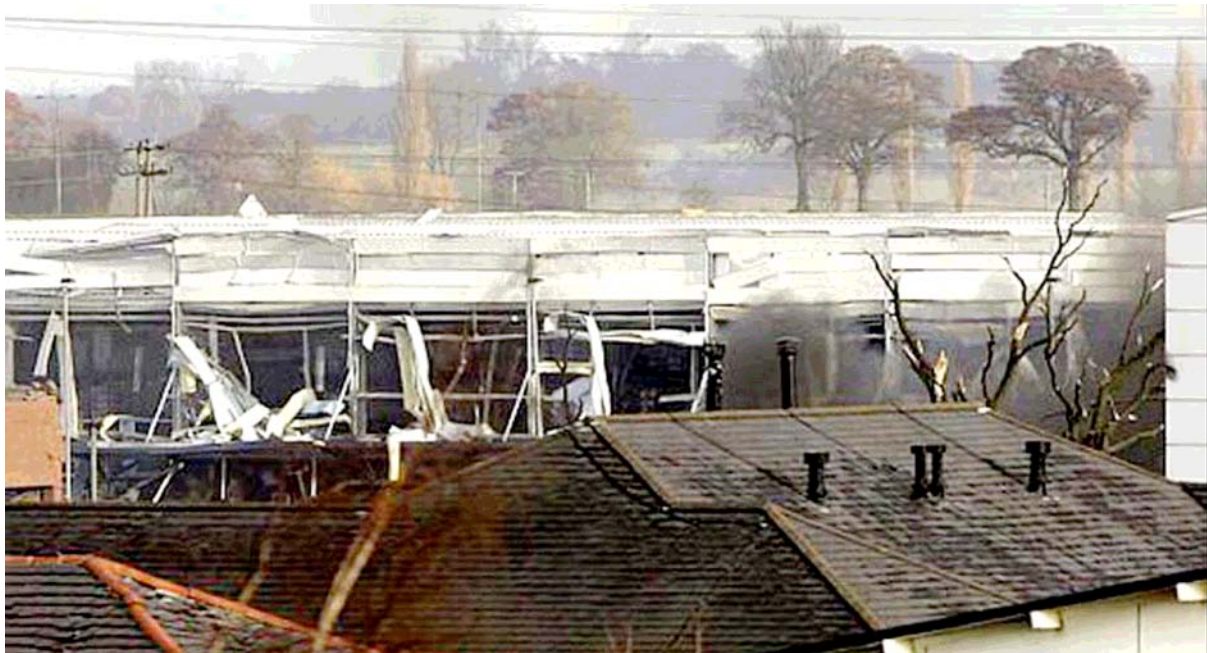
Metal façade destroyed along the whole length of Hall (5)

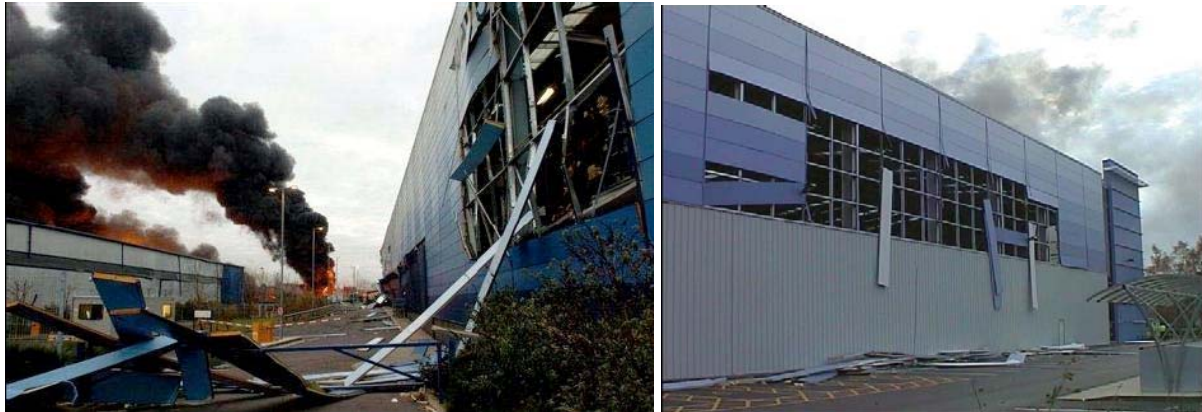
(7) East Entrance

An incident air shockwave that still had a maximum overpressure of about 0.1 bar was the decisive factor at the entrance between the two “East Halls” at a distance of about 350 m. Because of the position of the building façades, reflections of the atmospheric shockwave were scarcely a decisive factor at these positions. Due to the comparatively small pressure and based on the pattern of damage, it can be assumed that the damage to the façades visible in the following photos was caused by the overpressure inside the hall.

Façade elements forced outwards as a result of the overpressure in the interior of the Hall (5). The burning Tank 12 is recognisable in the background, about 250 metres away.

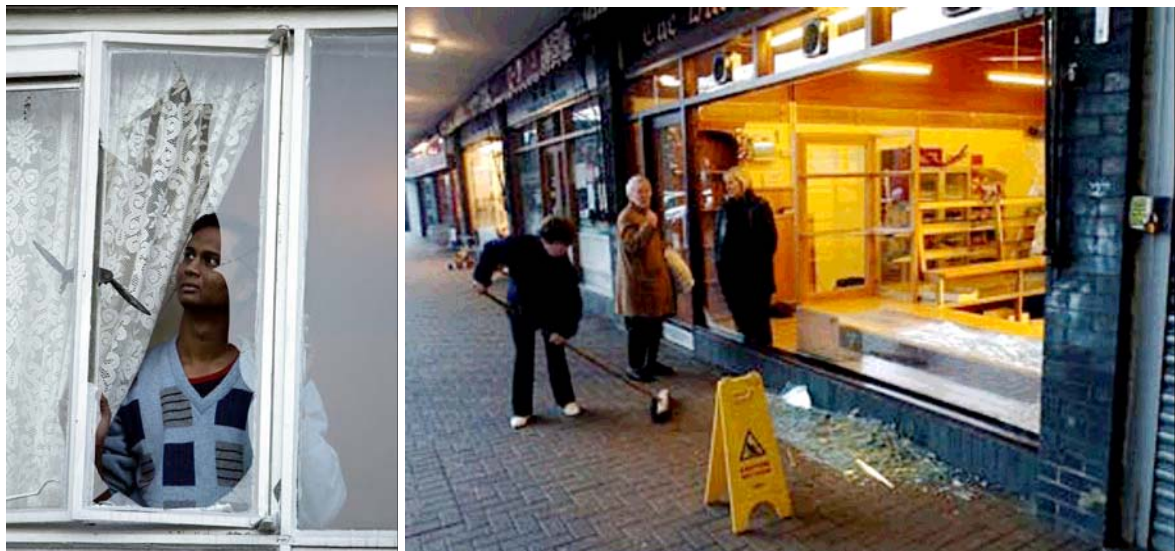
(8) Hemel Hempstead

The atmospheric shockwave caused by the explosion still caused glass windows to break in the town of Hemel Hempstead at a distance of one kilometre and more. The maximum overpressure of the reflected air shockwave at these locations was 0.05 bar or less.
