Buncefield Fire

Quick Look Report

bürkel baumann schuler

Swiss Fire Brigade Association

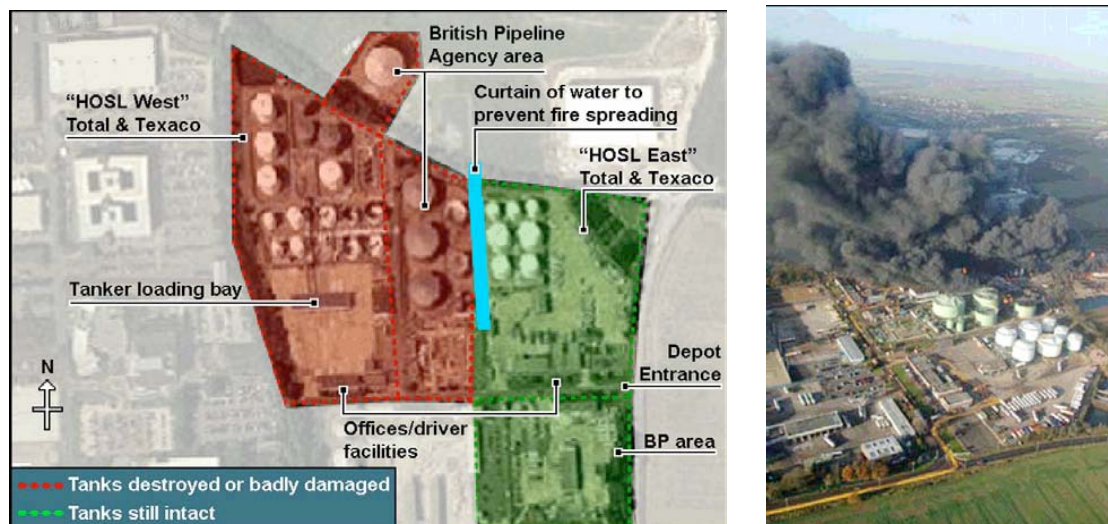
As a result of the fire incident, the northwest part of the installation with a total of 22 fuel tanks was destroyed or severely damaged. The size of the affected area is approx. 300 x 400 m and comprises an area of about 80,000 m².

The diagram above shows that the eastern part of the tank installation, “HOSL East”, was protected from the heat effect of the fires by a water curtain. However, an assessment of the visual image material shows that the *British Pipeline Agency* (BPA) tanks, which can be recognised in pale green colour in the above aerial photograph, were also not all involved in the fire. The seven white tanks in the “HOSL East” area, in which kerosene was stored, were not affected by the fire incident. Furthermore, the hosepipes that can be seen in the aerial photograph on the following page permit the conclusion that the deployment of extinguishing efforts took place primarily at BPA Tanks 4, 5 and 6. A plan with the tanks and their numbers can be found on the next page.

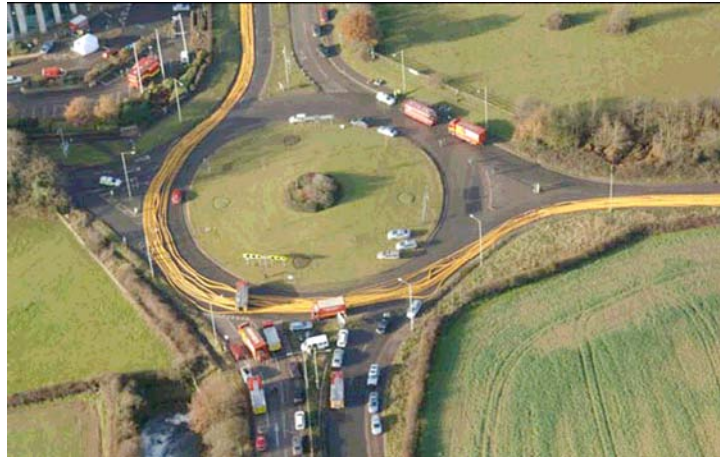
Hosepipes to transport extinguishing water, together with emergency services vehicles at a roundabout at Junction J8 of the M1 motorway at a distance of 1.2 km from the site of the fire.

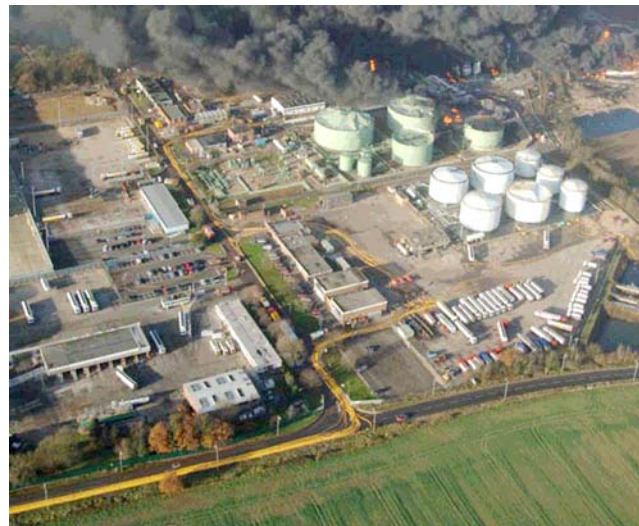
Hosepipes at the entrance to the HOSL Storage Tank Depot on the east side of the installation, and the layout of the hoses within the site.

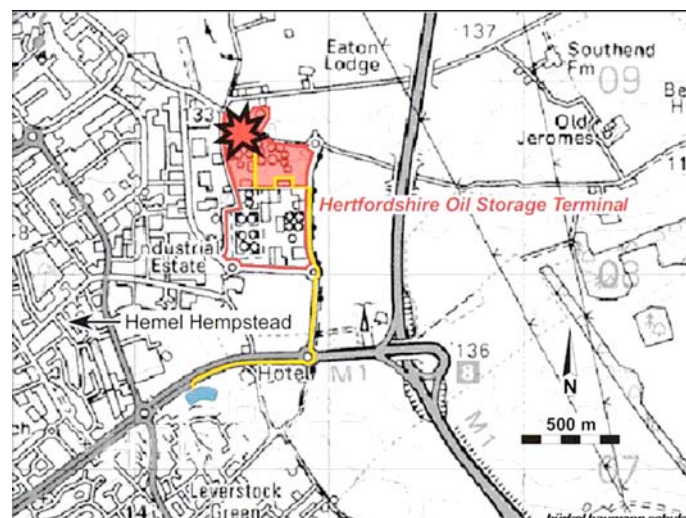
Excerpt from a map showing the route of the hosepipes to transport extinguishing water from a lake 1.6 km away.

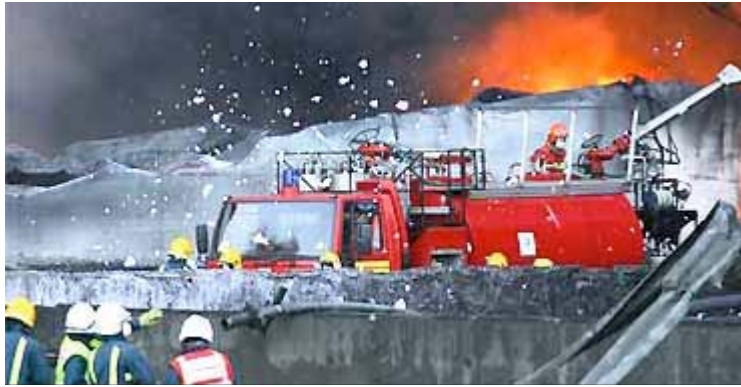
Fire-extinguishing vehicle with foam monitor in use

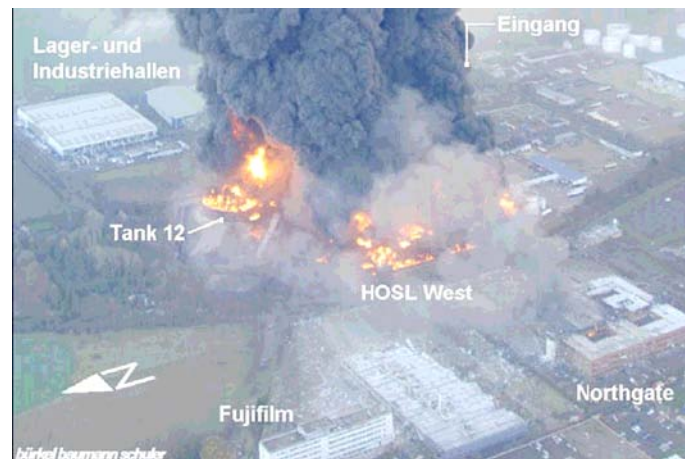
A few buildings in the vicinity of the fuel storage depot were severely damaged by the explosions and the effects of the subsequent fire. Based on the pattern of damage to the tank installations and surrounding buildings, it can be assumed that the explosions took place in the area with Tanks 913, 914 and 916. The head office of the IT company *Northgate Information Solutions*, which was closest to these tank installations, and the industrial hall situated alongside it were totally destroyed. The *Fujifilm* building together with two storage and industrial halls located to the east were also severely damaged.

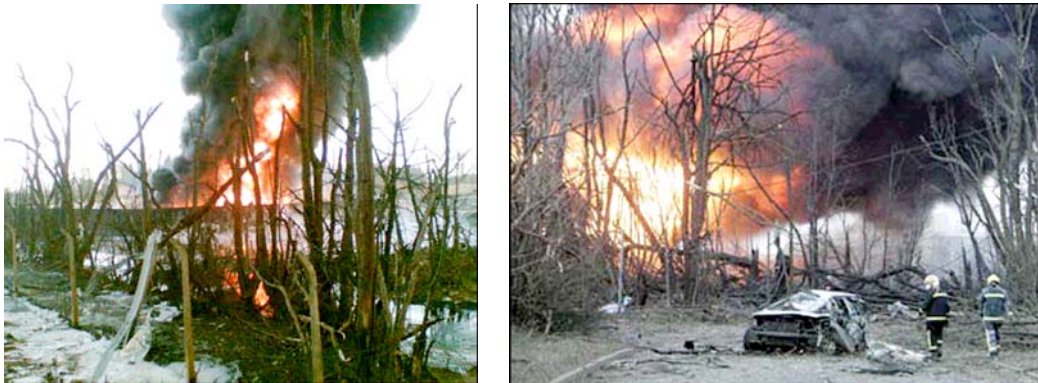
From eyewitness reports and from the photographic material it can be concluded that the thermal effects of the explosion fireball and the heat radiation from the subsequent fire were immense. Eyewitnesses report flames one hundred metres high. The burnt-out vegetation that surrounded the storage tank site to the north and west at a distance of about 40 m also permits conclusions to be drawn regarding intense thermal effects.

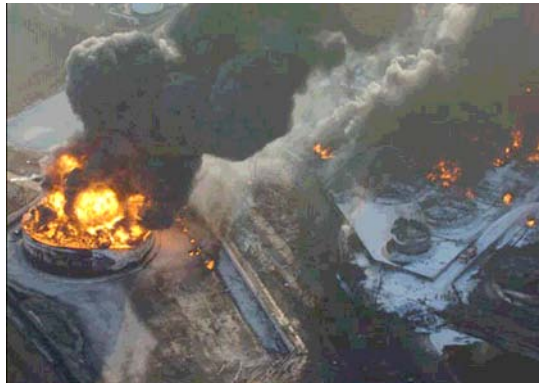
The fire at Tank 12 emitted the most smoke. This involved the largest tank on the HOSL storage tank depot site. Its capacity can be estimated as about 20,000 m³. Based on the photographs, it can be assumed that the Fire Brigade allowed the tank to burn out and did not extinguish it. A description of the smoke dispersal and the associated ecological and health aspects can be found in the following Section 3.4.

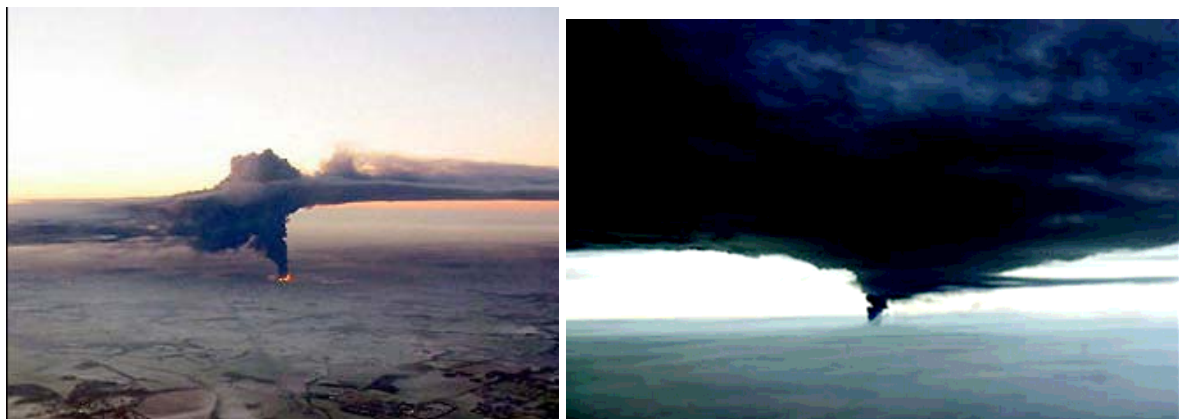
Smoke plume at a height of 2,000 – 3000 metres above the ground

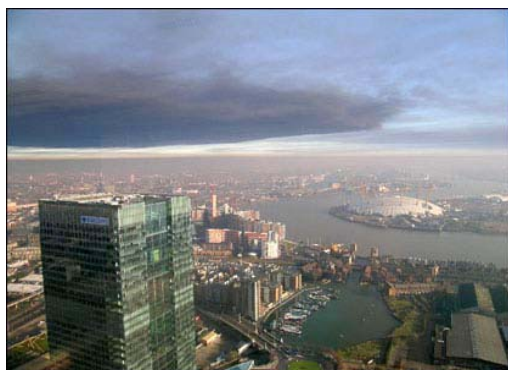
Smoke plume over London

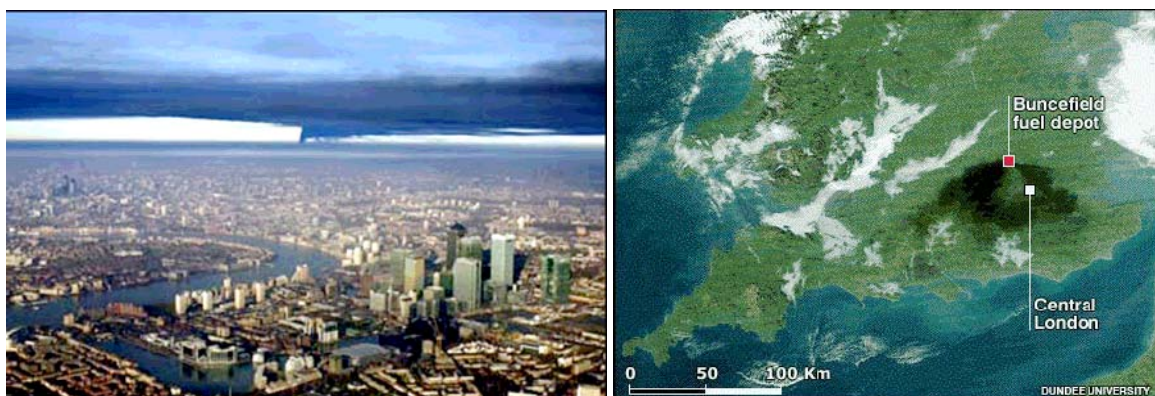
The smoke plume extended 100 km in an east-west direction and 50 km in a southerly direction.
